Metallurgical Evaluation of Cracked In-Service Heavy Duty Pile Bonnets

CTLGroup was retained by an industrial construction company in order to determine the cause for multiple in-service failures of heavy-duty pile bonnets. The fractured bonnets were reportedly purchased new from an offshore supplier and were considered to have failed well short of anticipated service life.

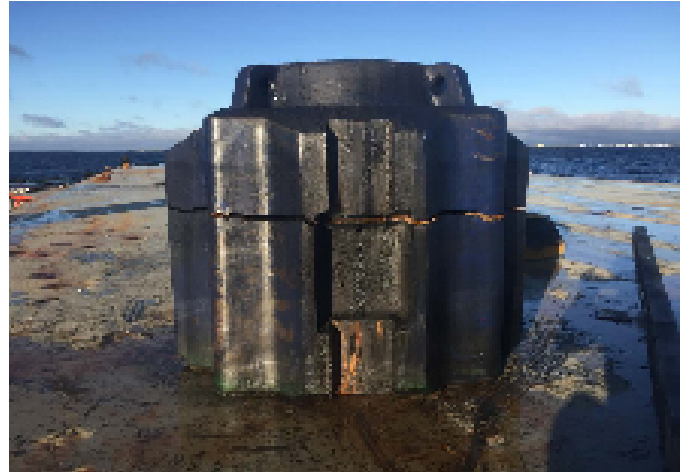
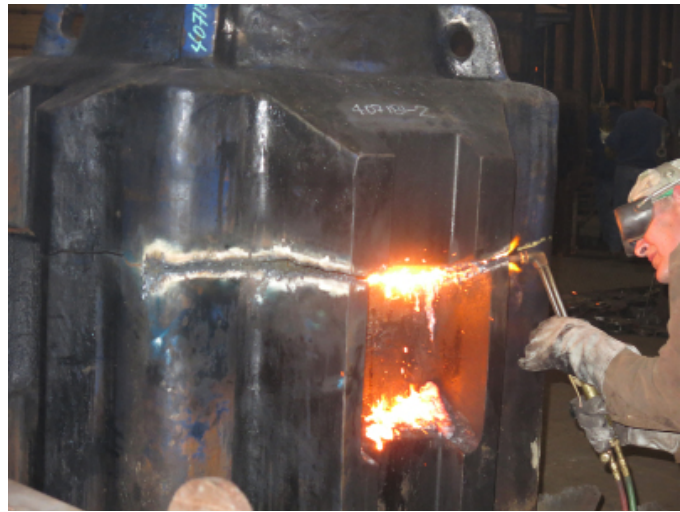
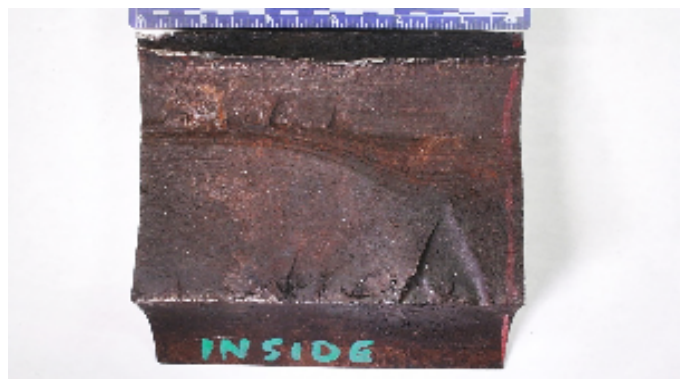
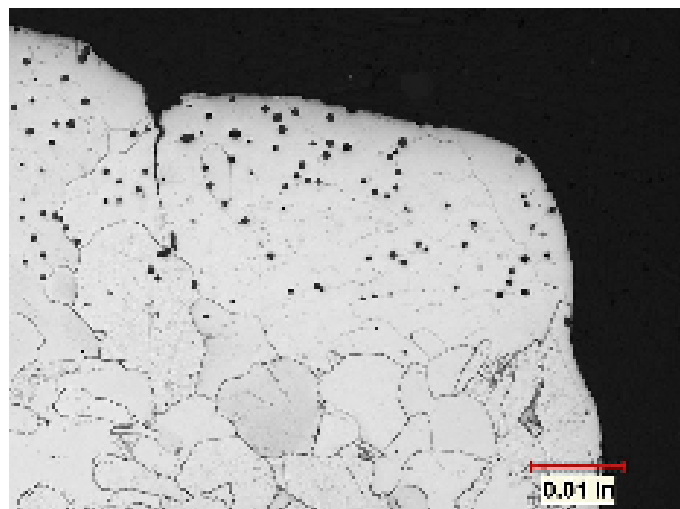
Fractures appeared to progress along significant portions of the pile bonnet perimeter, and penetrated full cross-sectional thickness for a significant portion of the crack propagation path. Examination of the fracture within the pile insert receptacle cavity revealed that the fracture path propagated through the toe of the casting radius formed at the cushion receptacle, adjacent to the pile insert receptacle cavity wall.

DPA revealed that the cracking resulted from multiple origin fatigue fractures, which initiated around the entire circumference of the cast surface of the pile internal insert cavity wall. At some point during the pile bonnet operational lifetime, primary fatigue cracking was arrested, and secondary fatigue was re-initiated at the arrest locations of the primary fatigue propagation.

Metallographic specimens revealed the presence of a significant layer of oversized MnS and SiO₂ inclusions at the primary fatigue origins. CTLGroup determined that the observed microstructural anomalies, which are indicative of poorly controlled foundry practices, compromised the functional integrity of the pile bonnets and resulted in premature failure of the units.
