Condominium Railing + Balcony Materials Failure Investigation

MIAMI, FLORIDA

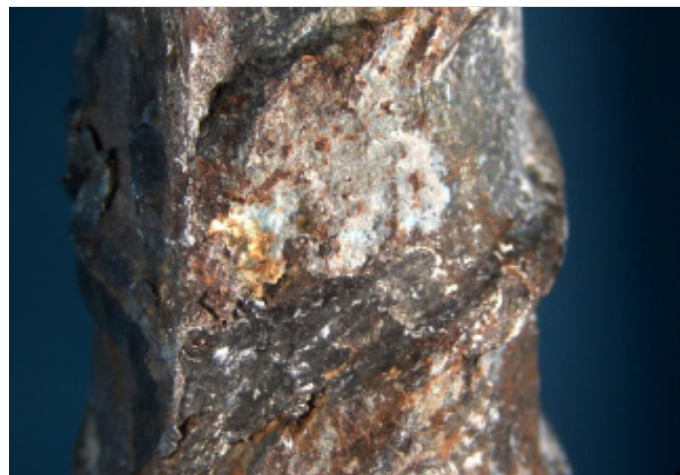
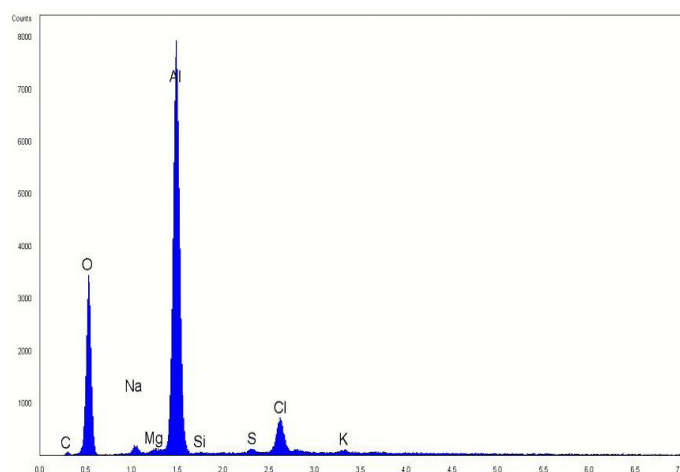
Observed corrosion of reinforcing bars (rebar situated within the balcony concrete), the delamination, spalling and cracking of post pocket grout and balcony concrete surrounding the aluminum railing columns (posts), as well as aluminum balcony railing coating failures and railing corrosion were material defects investigated.

The laboratory investigation confirmed the presence of corrosion products on aluminum railings and exposed rebar and revealed that an alkali resistant coating was not applied to the aluminum railing embedded in the post pocket grouts. Further, the railing coating was identified as a polyester powder type and not a more durable PVDF coating.
